**PRELIMINARY ASSESSMENT
FOR
DIAZ INTERMEDIATES CORPORATION
AFIN No. 18-00401
WEST MEMPHIS, CRITTENDEN COUNTY, ARKANSAS**

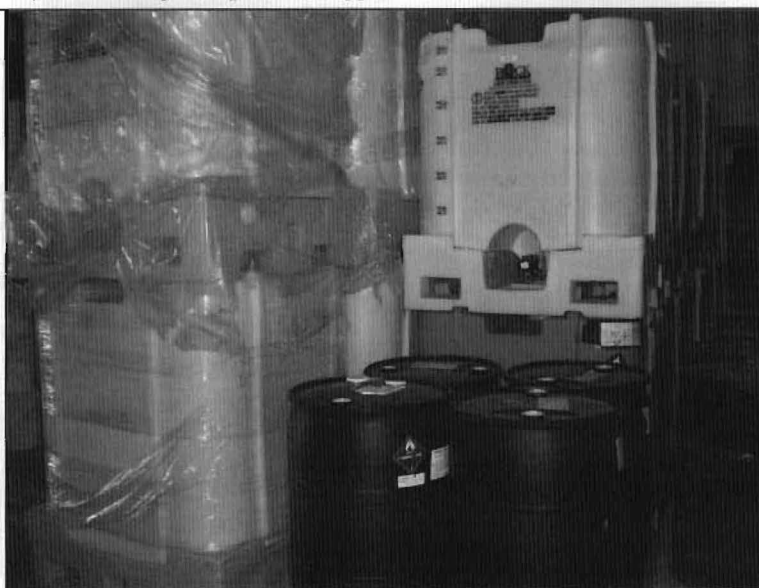
Location:		Diaz Intermediates Corp., 301 Wyanoke Rd., West Memphis, AR 72301							
Photographer:		Les Branscum, ADEQ				Witness:		Penny Wilson, ADEQ	
Photo #	3	Of	67			Date:	28 AUG 07	Time:	1047
Description:		Facing south in the Diaz warehouse. These are 5 gal pails of P-Dibromobenzene (99%). Containers on top of pails are empty. These items are to the left of those in photos 1 & 2.

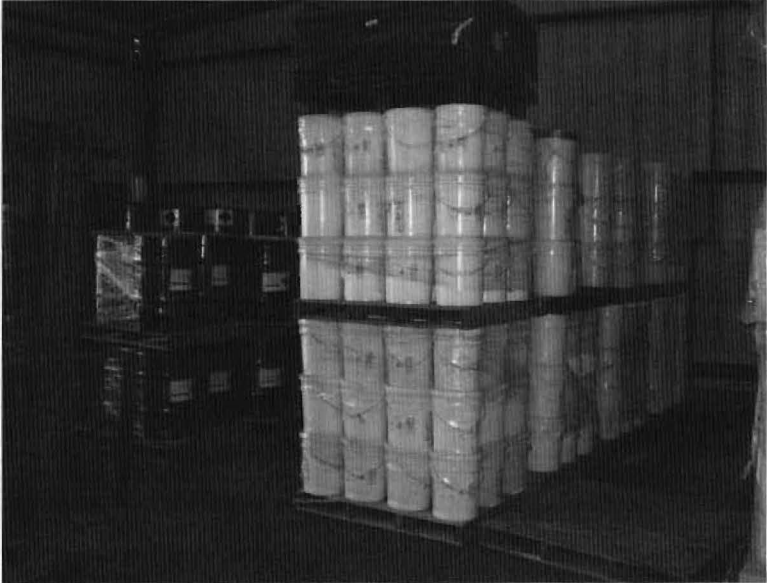
Photographer:		Les Branscum, ADEQ				Witness:		Penny Wilson, ADEQ	
Photo #	4	Of	67			Date:	28 AUG 07	Time:	1050
Description:		Drums to the left of those in photo 3; black 30 gal drums of Aluminum Chloride, Anhydrous and blue 55 gal drums of Methanol.

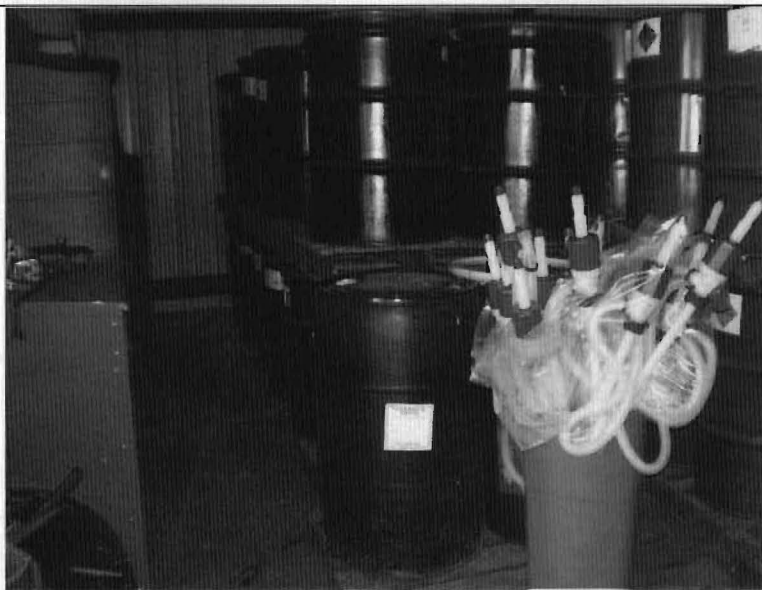
Location:	Diaz Intermediates Corp., 301 Wyanoke Rd., West Memphis, AR 72301						
Photographer:	Les Branscum, ADEQ			Witness:	Penny Wilson, ADEQ		
Photo #	5	Of	67	Date:	28 AUG 07	Time:	1054
Description:		Southeast corner of the Diaz warehouse. Items in foreground are drum pumps with one drum of hazardous waste Benzene behind them. Drums stacked 2 high are Di-Bromobenzene (R).

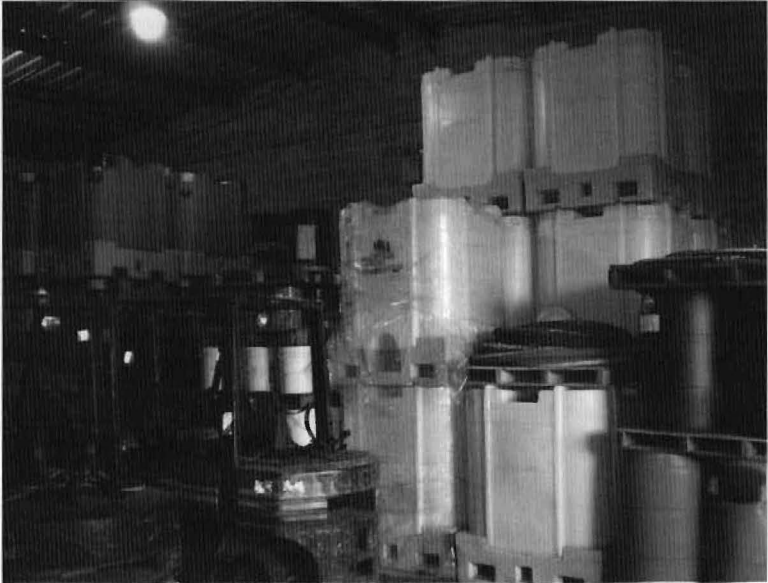
Photographer:		Les Branscum, ADEQ			Witness:		Penny Wilson, ADEQ	
Photo #	8	Of	67		Date:	28 AUG 07	Time:	1106
Description:		North wall of warehouse, opposite side of totes in photo 7. 5 gal white pails contain P-Bromochlorobenzene. Blue pails on top of these are labeled P-Dibromobenzene.

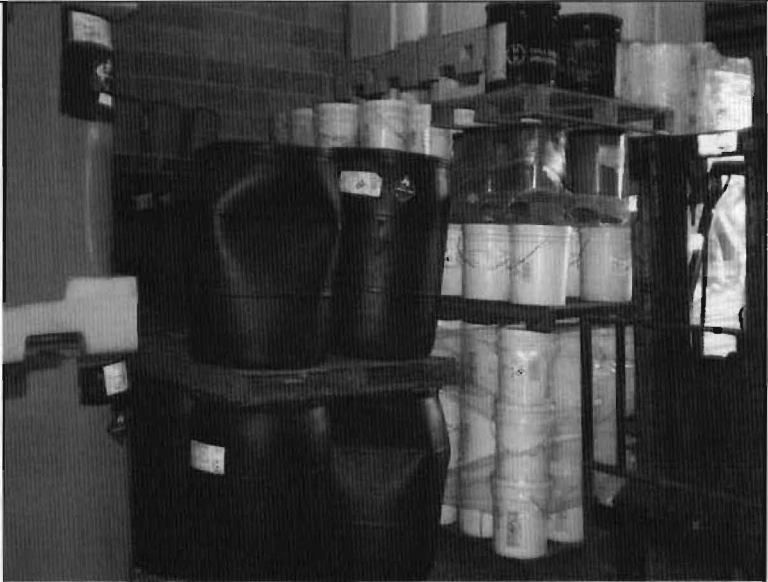
Location:	Diaz Intermediates Corp., 301 Wyanoke Rd., West Memphis, AR 72301						
Photographer:	Les Branscum, ADEQ				Witness:	Penny Wilson, ADEQ	
Photo #	9	Of	67		Date:	28 AUG 07	Time: 1111
Description:	Two 5 gal cans on top of the stack in photo 8. These are labeled 'Phosphorus, Amorphous- Red Phosphorous (99%)'.

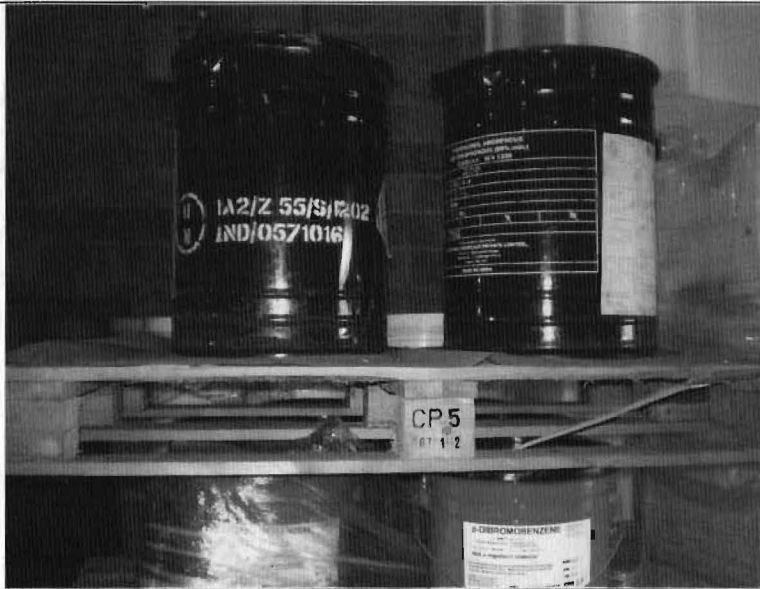
Photographer:	Les Branscum, ADEQ				Witness:	Penny Wilson, ADEQ	
Photo #	10	Of	67		Date:	28 AUG 07	Time: 1114
Description:	Northwest corner of warehouse, 275 gal blue totes labeled N-Propylbromide.

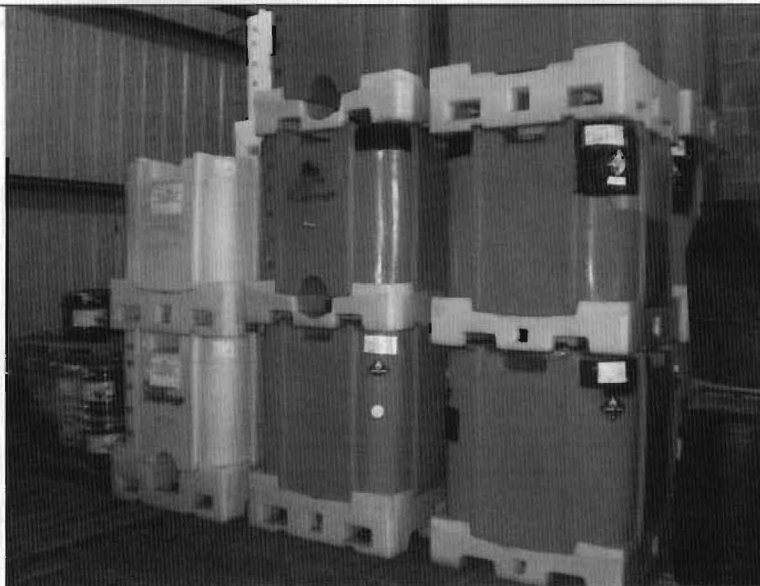
Location:	Diaz Intermediates Corp., 301 Wyanoke Rd., West Memphis, AR 72301							
Photographer:	Les Branscum, ADEQ				Witness:	Penny Wilson, ADEQ		
Photo #	11	Of	67		Date:	28 AUG 07	Time:	1118
Description:	Northwest corner of Diaz warehouse showing 220 gal totes of N-Propylbromide and black 65 lb cans of Ferric Chloride.

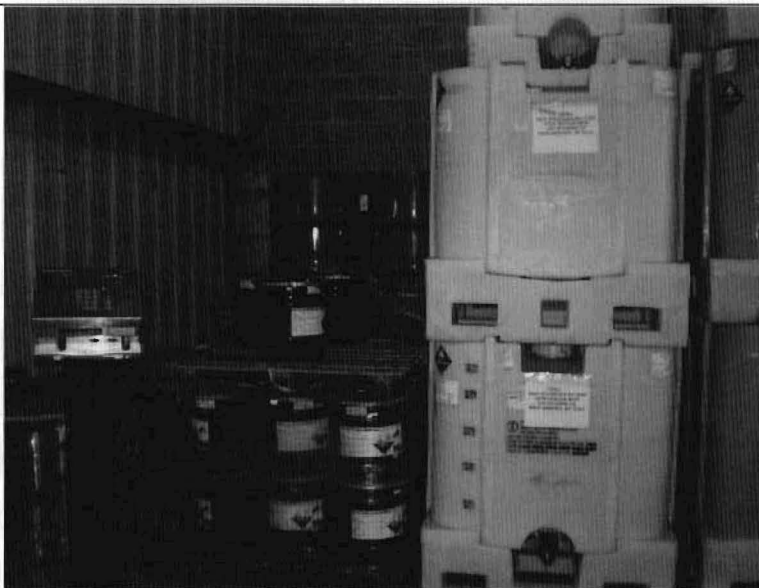
Photographer:	Les Branscum, ADEQ				Witness:	Penny Wilson, ADEQ		
Photo #	12	Of	67		Date:	28 AUG 07	Time:	1122
Description:	275 gal totes on the loading dock, east side of the warehouse facing NE. Totes contain Caustic Soda (50%).

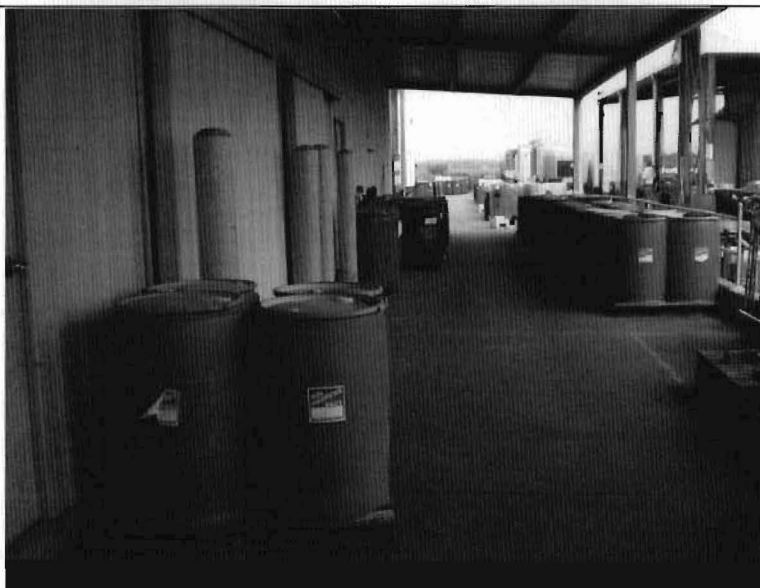
Photographer:	Les Branscum, ADEQ			Witness:	Penny Wilson, ADEQ		
Photo #	14	Of	67	Date:	28 AUG 07	Time:	1127
Description:		Forklift path on north end of loading dock facing north. Above ground tanks in containment are to the left.

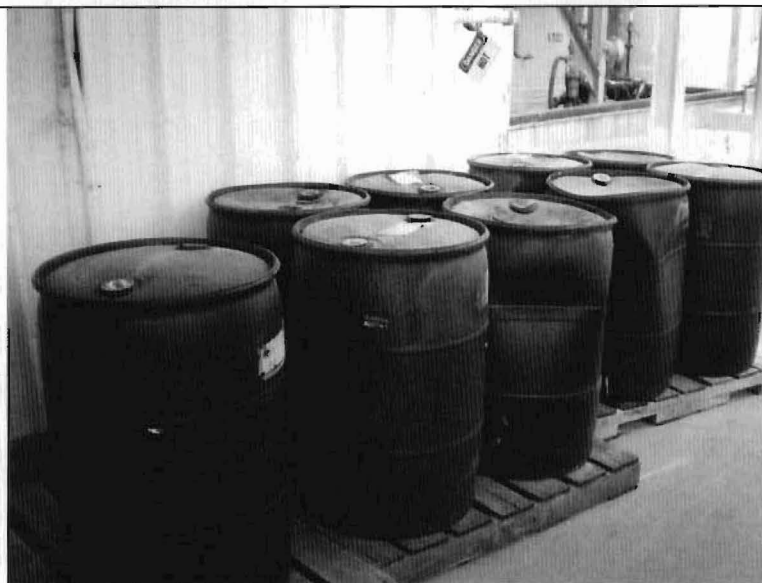
Photographer:	Les Branscum, ADEQ			Witness:	Penny Wilson, ADEQ		
Photo #	17	Of	67	Date:	28 AUG 07	Time:	1138
Description:		North end of the loading dock showing the condition of some of the poly drums. These drums were filled while the contents were hot, causing them to indent.

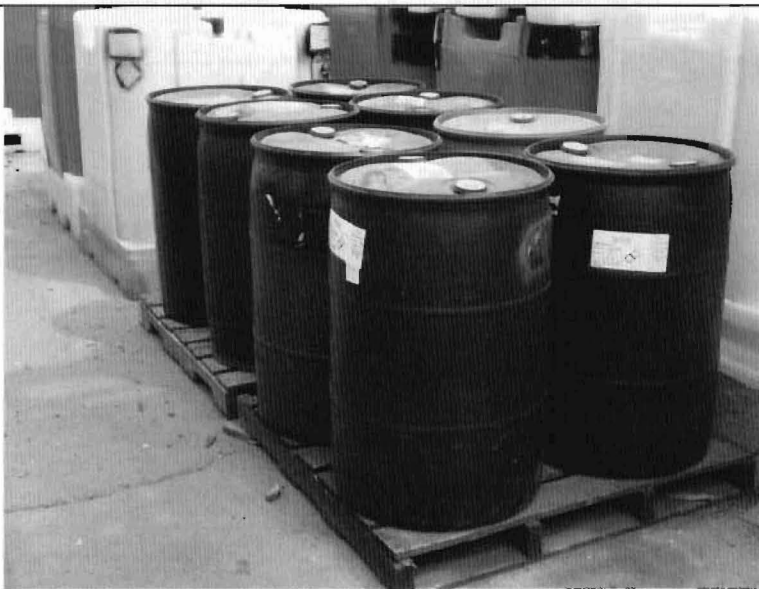
Photographer:	Les Branscum, ADEQ				Witness:	Penny Wilson, ADEQ	
Photo #	19	Of	67		Date:	28 AUG 07	Time: 1153
Description:	275 gal totes to the left of the drums in photo 18 labeled M-Bromofluorobenzene 65%.

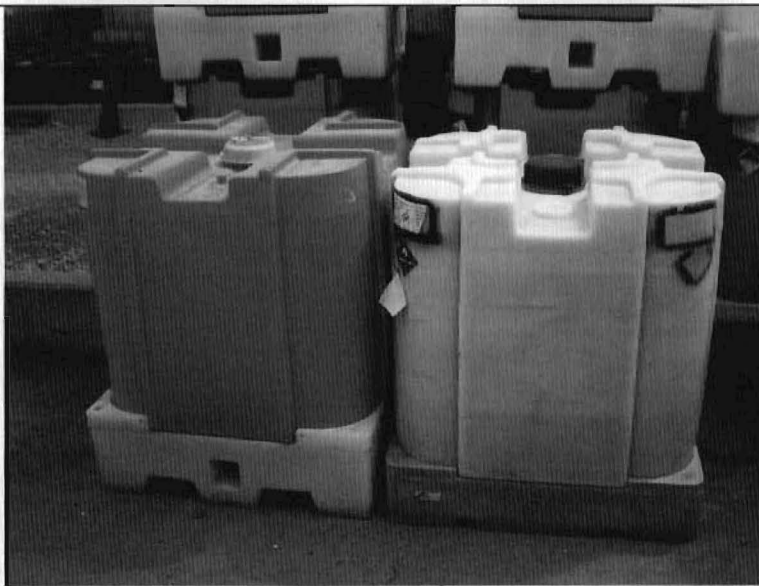
Location:	Diaz Intermediates Corp., 301 Wyanoke Rd., West Memphis, AR 72301						
Photographer:	Les Branscum, ADEQ				Witness:	Penny Wilson, ADEQ	
Photo #	20	Of	67		Date:	28 AUG 07	Time: 1155
Description:	275 gal totes on right side of forklift path, facing NE. The blue tote is labeled M-Bromofluorobenzene; white ones contain pit water (zinc).

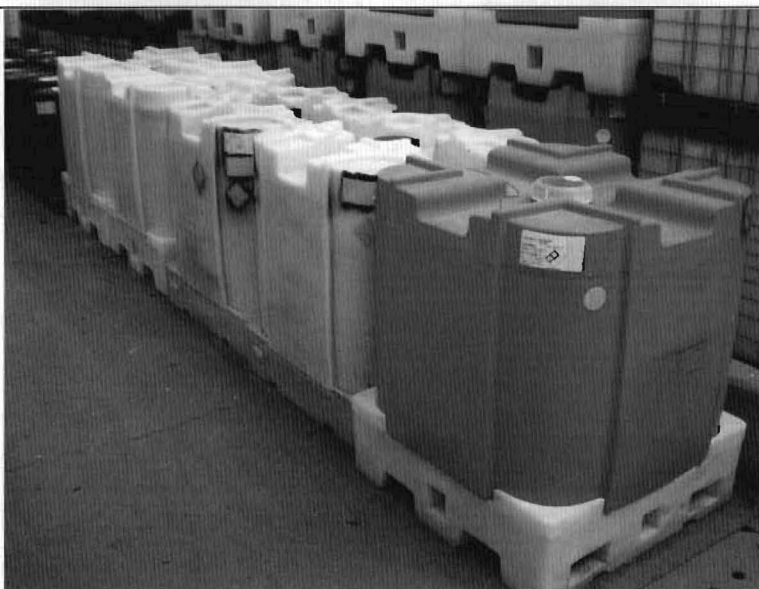
Photographer:	Les Branscum, ADEQ				Witness:	Penny Wilson, ADEQ	
Photo #	21	Of	67		Date:	28 AUG 07	Time: 1157
Description:	Continuing north on the right side of the fork lift path, stand of 55 gal drums. Labels on drums at right read 'DBFB Dibromotoluene Mix'.

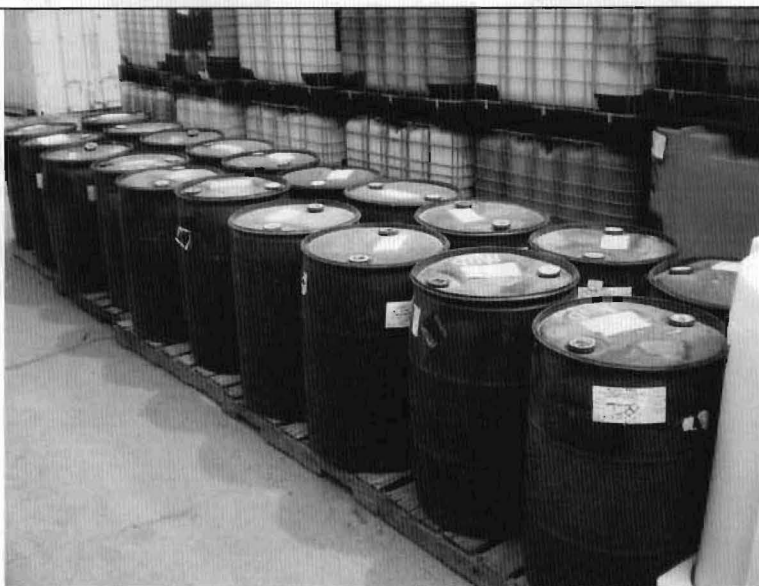
Location:		Diaz Intermediates Corp., 301 Wyanoke Rd., West Memphis, AR 72301					
Photographer:		Les Branscum, ADEQ			Witness:		Penny Wilson, ADEQ
Photo #	22	Of	67		Date:	28 AUG 07	Time: 1159
Description:		Left side of forklift path facing north. The eight 55 gal drums centered in the photo are all labeled 'DBFB, Dibromotoluene Mix'.

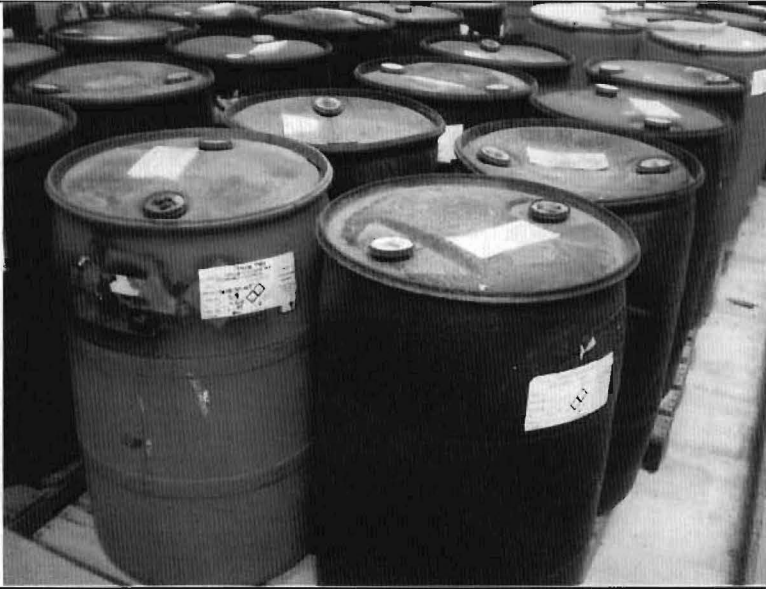
Photographer:		Les Branscum, ADEQ			Witness:		Penny Wilson, ADEQ
Photo #	23	Of	67		Date:	28 AUG 07	Time: 1202
Description:		Drums just north of those in photo 22. Blue drum to the left is labeled 'MBFB Waste pads/filters'. New and old tank farms are to the left of the photo.

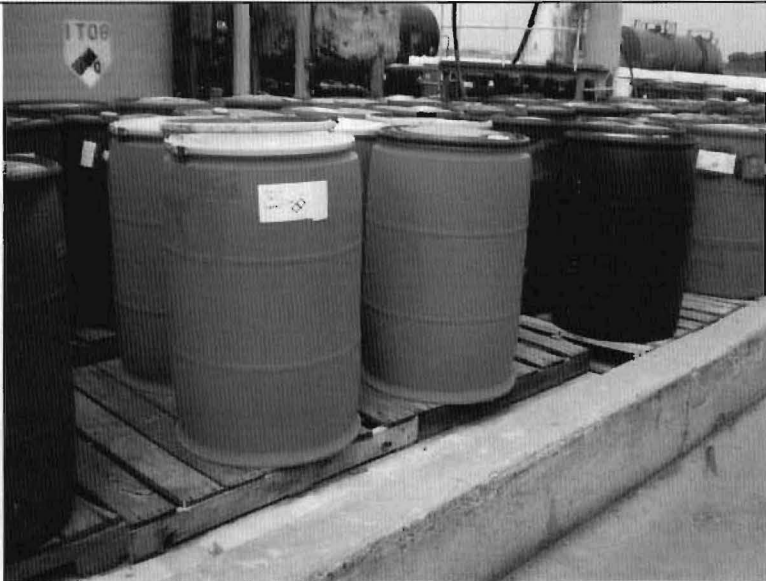
Location:	Diaz Intermediates Corp., 301 Wyanoke Rd., West Memphis, AR 72301						
Photographer:	Les Branscum, ADEQ				Witness:	Penny Wilson, ADEQ	
Photo #	24	Of	67		Date:	28 AUG 07	Time: 1204
Description:	Drums on pad east of 'tank farm', facing NW. Drum on left is labeled 'Mixed Organics (R) Overhead'.

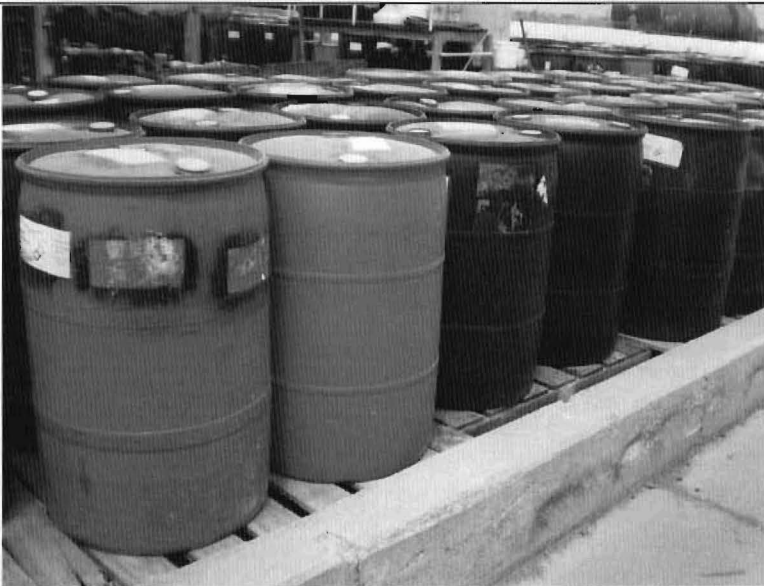
Photographer:	Les Branscum, ADEQ				Witness:	Penny Wilson, ADEQ	
Photo #	25	Of	67		Date:	28 AUG 07	Time: 1212
Description:	Opposite view of drums in photo 24, facing SW with tank farm in background. Last 4 drums on the end of the left row and 2 rows to the right are labeled X-Bromotoluene (T) Bottoms.

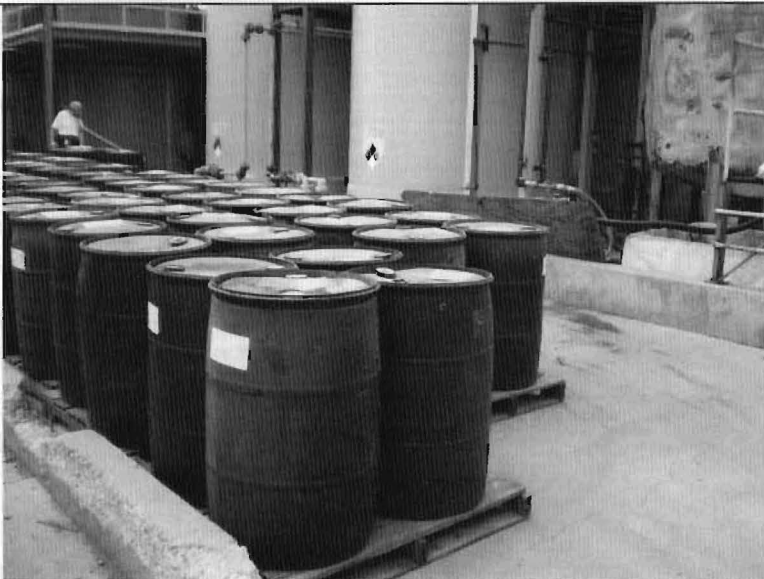
Location:	Diaz Intermediates Corp., 301 Wyanoke Rd., West Memphis, AR 72301						
Photographer:	Les Branscum, ADEQ			Witness:	Penny Wilson, ADEQ		
Photo #	26	Of	67	Date:	28 AUG 07	Time:	1215
Description:	Drums of X-Bromotoluene (C) Crude on opposite end of drums in photo 25, facing south.

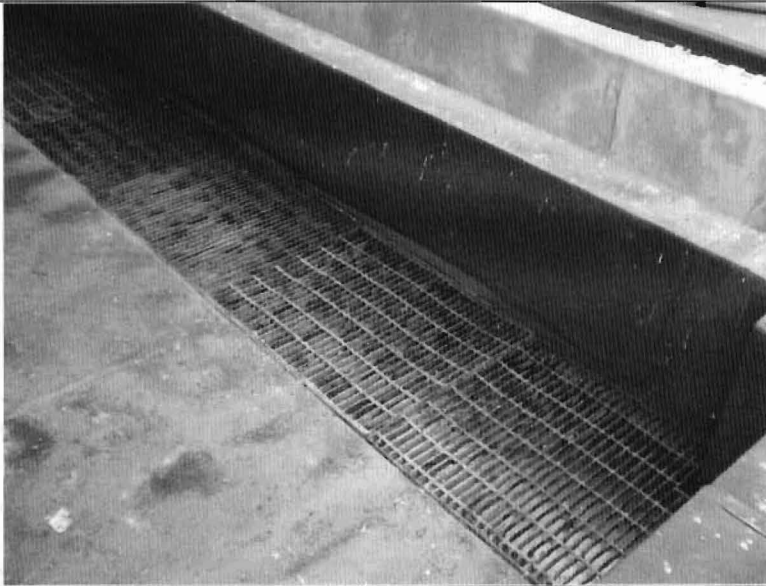
Photographer:		Les Branscum, ADEQ				Witness:		Penny Wilson, ADEQ	
Photo #	29	Of	67			Date:	28 AUG 07	Time:	1331
Description:		New tank farm containment area with standing water. The Spilfyter test strip indicated the Ph for this water between 9 and 10.

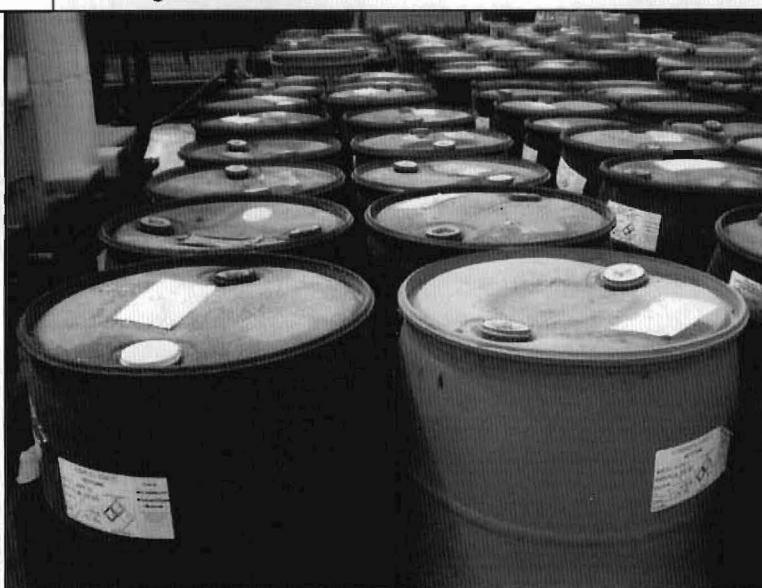
Location:	Diaz Intermediates Corp., 301 Wyanoke Rd., West Memphis, AR 72301						
Photographer:	Les Branscum, ADEQ			Witness:	Penny Wilson, ADEQ		
Photo #	32	Of	67	Date:	28 AUG 07	Time:	1348
Description:	Next 2 rows (row 3&4) of drums on drum pad north of the tank farm, facing west. Drum in left foreground is labeled Dibromotoluene.

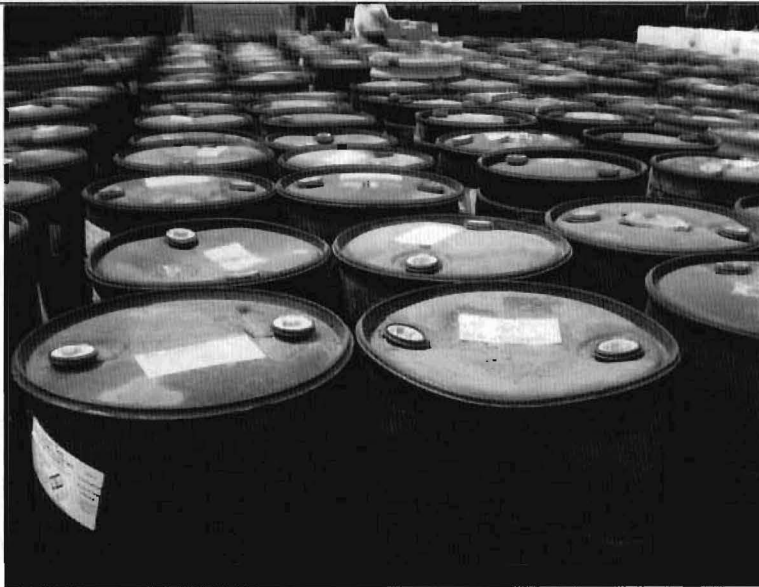
Photographer:	Les Branscum, ADEQ			Witness:	Penny Wilson, ADEQ		
Photo #	33	Of	67	Date:	28 AUG 07	Time:	1352
Description:	Rows 5&6 on the drum pad, facing west.

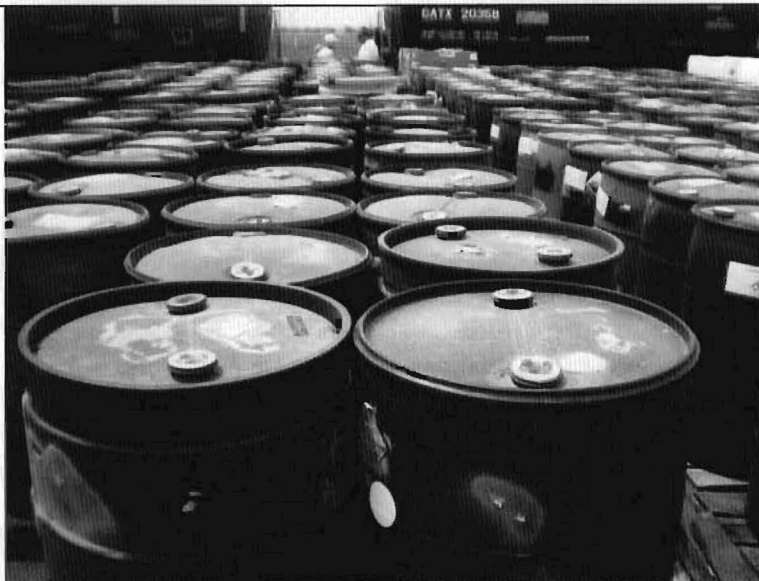
Location:	Diaz Intermediates Corp., 301 Wyanoke Rd., West Memphis, AR 72301						
Photographer:	Les Branscum, ADEQ			Witness:	Penny Wilson, ADEQ		
Photo #	34	Of	67	Date:	28 AUG 07	Time:	1354
Description:	View of rows 5&6 from opposite end showing blue drum on right has a bulging top. Drum is labeled 'M-Dibromobenzene'. Photo facing east.

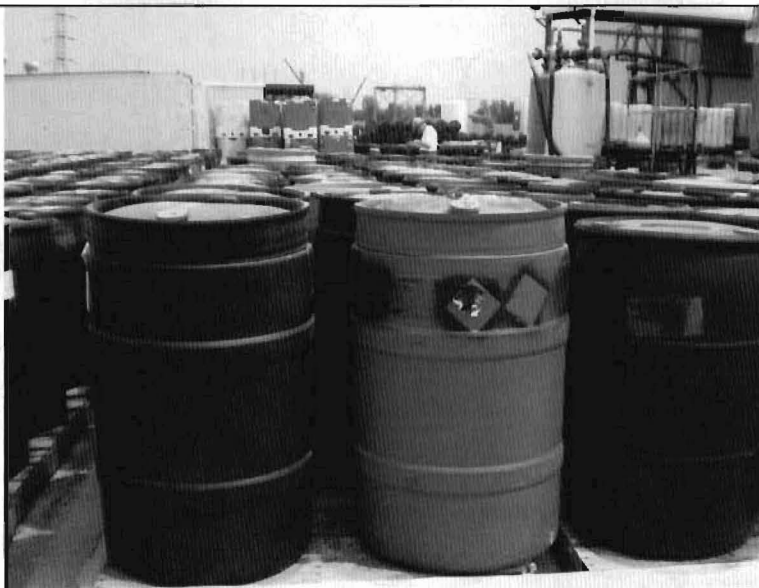
Photographer:	Les Branscum, ADEQ			Witness:	Penny Wilson, ADEQ		
Photo #	35	Of	67	Date:	28 AUG 07	Time:	1358
Description:	Poly drum (3 rd from end in above photo of row 6) not leaking but crushed in, no label visible. Photo facing east.

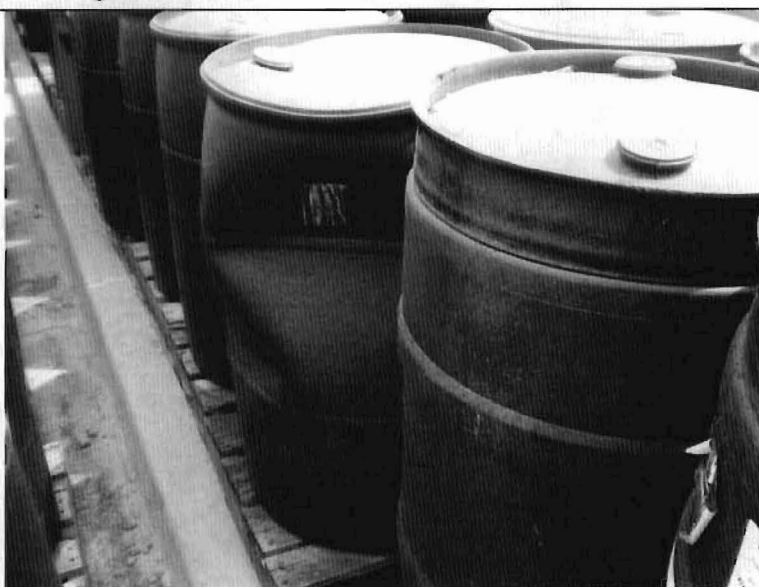
Location:	Diaz Intermediates Corp., 301 Wyanoke Rd., West Memphis, AR 72301						
Photographer:	Les Branscum, ADEQ				Witness:	Penny Wilson, ADEQ	
Photo #	36	Of	67		Date:	28 AUG 07	Time: 1402
Description:	Rows 7&8 on drum pad, facing west. Rail car in background is labeled 'Fluorobenzene' UN 2387, Flammable Liquid.

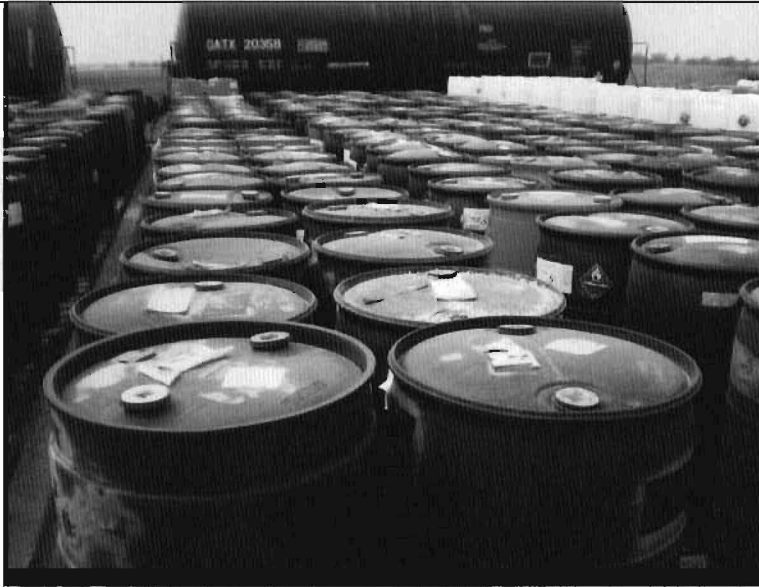
Photographer:	Les Branscum, ADEQ				Witness:	Penny Wilson, ADEQ	
Photo #	37	Of	67		Date:	28 AUG 07	Time: 1403
Description:	Residue on top of 2 nd drum in row 8, photo 36. Drum is labeled 'Bromobenzene recycle'.

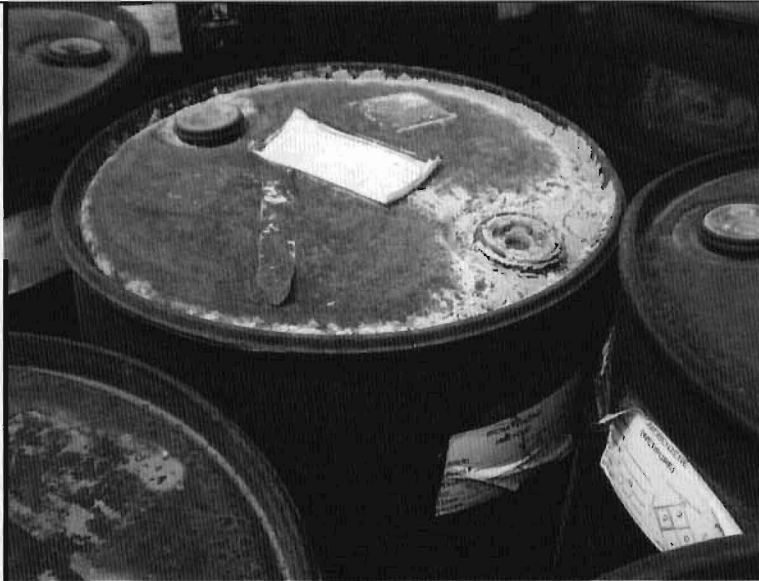
Location:		Diaz Intermediates Corp., 301 Wyanoke Rd., West Memphis, AR 72301						
Photographer:		Les Branscum, ADEQ			Witness:		Penny Wilson, ADEQ	
Photo #	38	Of	67		Date:	28 AUG 07	Time:	1405
Description:		Rows 9&10 on drum pad, facing west. Labels on first two drums indicate they contain '-Propyl Bromide (Tech)'.

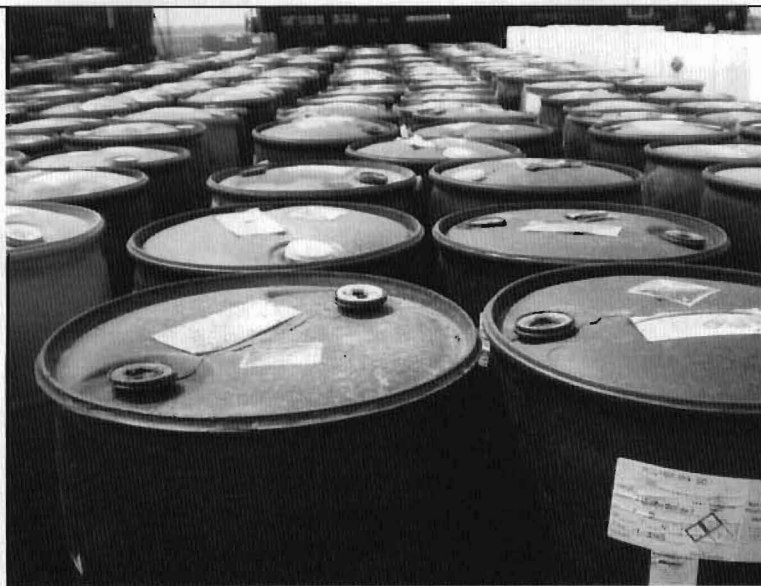
Location:	Diaz Intermediates Corp., 301 Wyanoke Rd., West Memphis, AR 72301							
Photographer:	Les Branscum, ADEQ				Witness:	Penny Wilson, ADEQ		
Photo #	40	Of	67		Date:	28 AUG 07	Time:	1408
Description:		Bulging lid on corrosive labeled drum in row 11. Product label indicates the drum contains 'HCL/HBR mix HG>1.1', DATED 1-21-07.

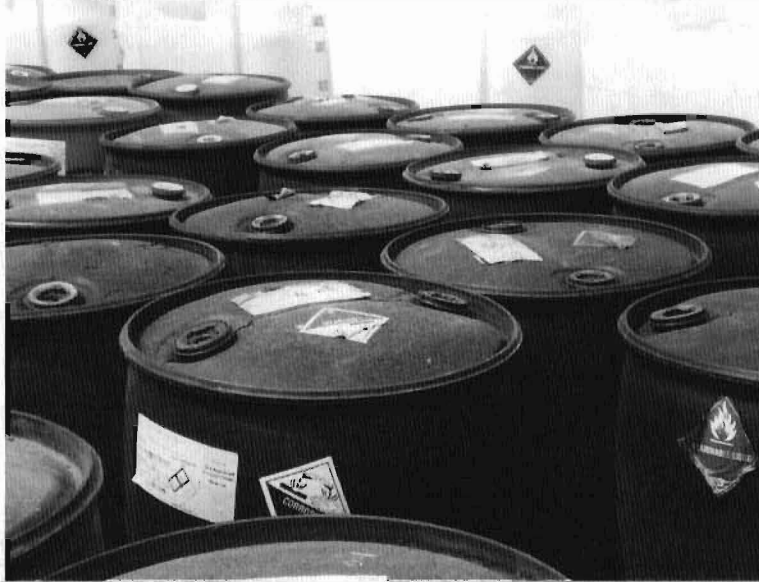
Photographer:	Les Branscum, ADEQ				Witness:	Penny Wilson, ADEQ		
Photo #	41	Of	67		Date:	28 AUG 07	Time:	1409
Description:		Rows 13&14 on drum pad, facing west.

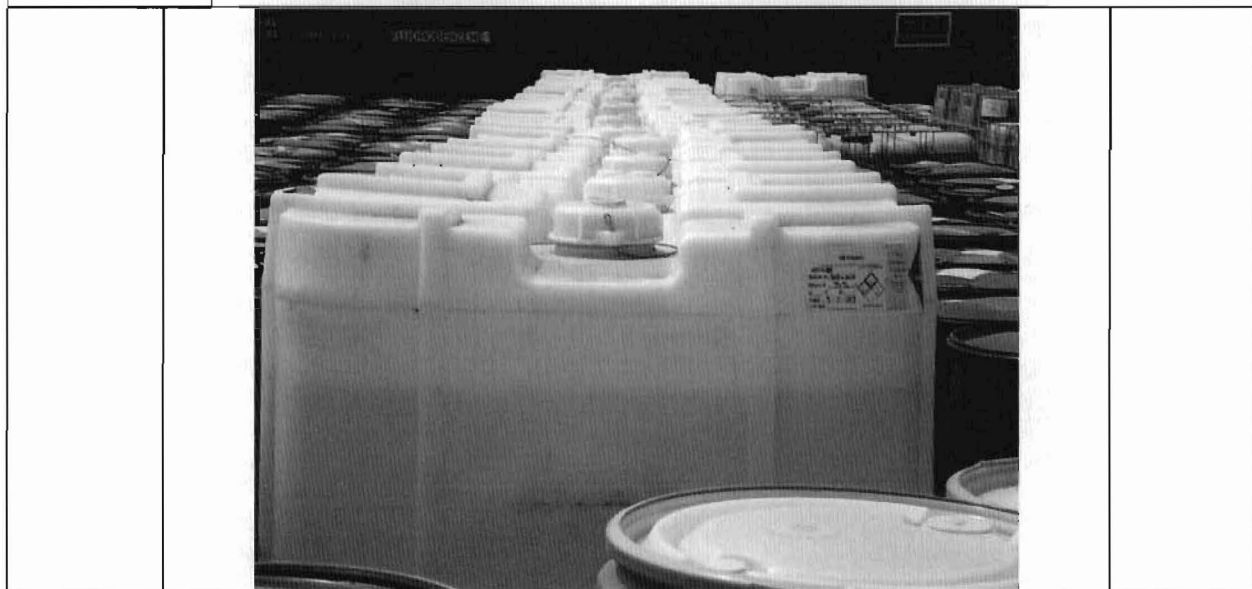
Photographer:	Les Branscum, ADEQ			Witness:	Penny Wilson, ADEQ		
Photo #	43	Of	67	Date:	28 AUG 07	Time:	1412
Description:	Row 16 facing west, drum in front is labeled 'MBFB(H) Nondistilled Water'

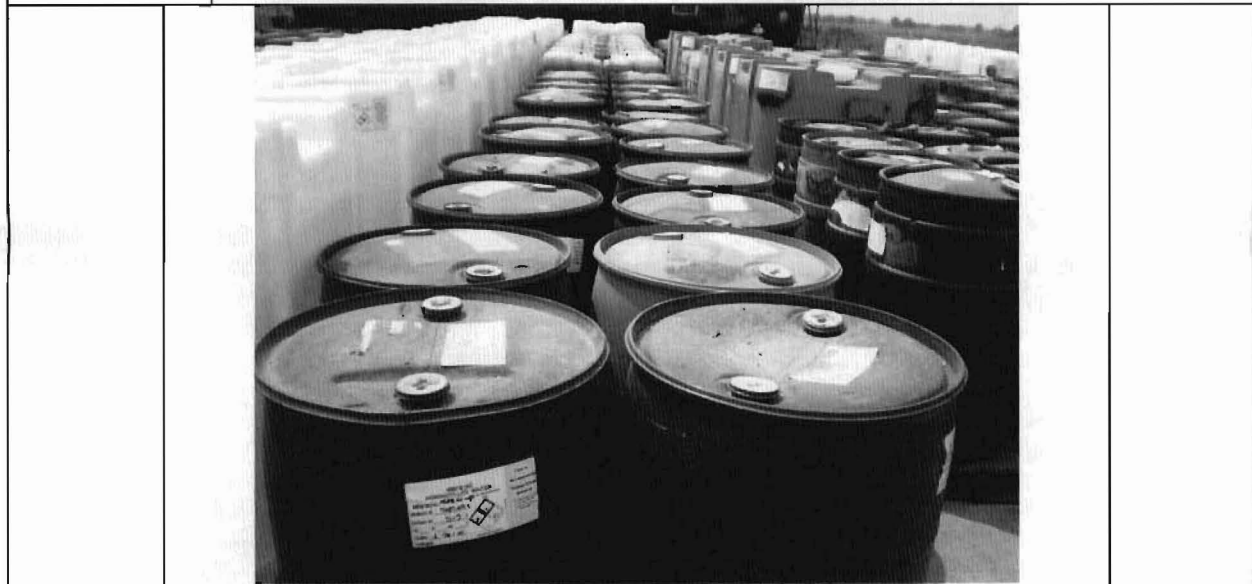
Description: Row 17 facing west, majority of row is totes two drums wide.

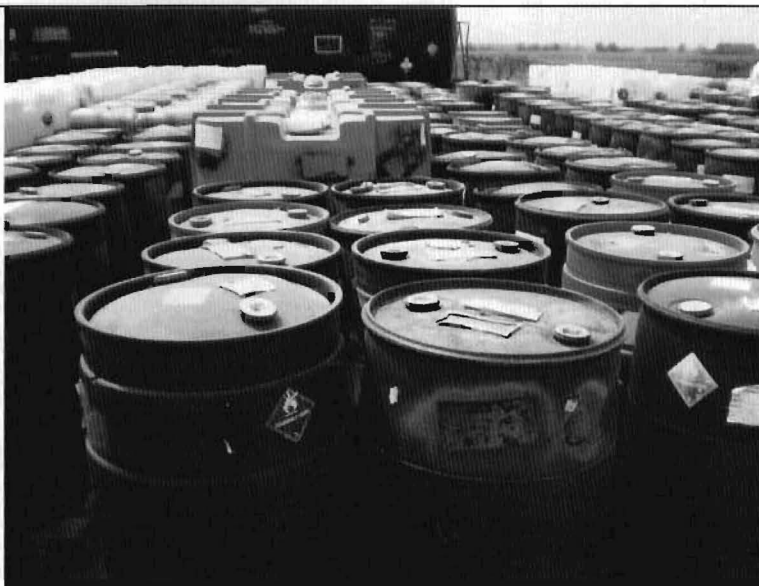
Description: Row 18 facing west, front drum is labeled 'Bromobenzene PDBB-Extraction'.

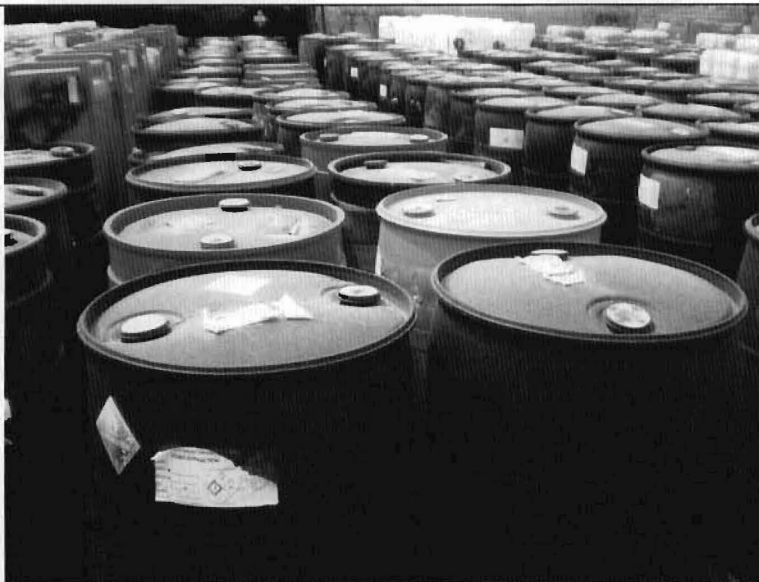
Location:		Diaz Intermediates Corp., 301 Wyanoke Rd., West Memphis, AR 72301					
Photographer:		Les Branscum, ADEQ			Witness:		Penny Wilson, ADEQ
Photo #	46	Of	67		Date:	28 AUG 07	Time:
Description:		Row 19 facing west. Blue drum is labeled 'Bromobenzene Pot Bottoms'.

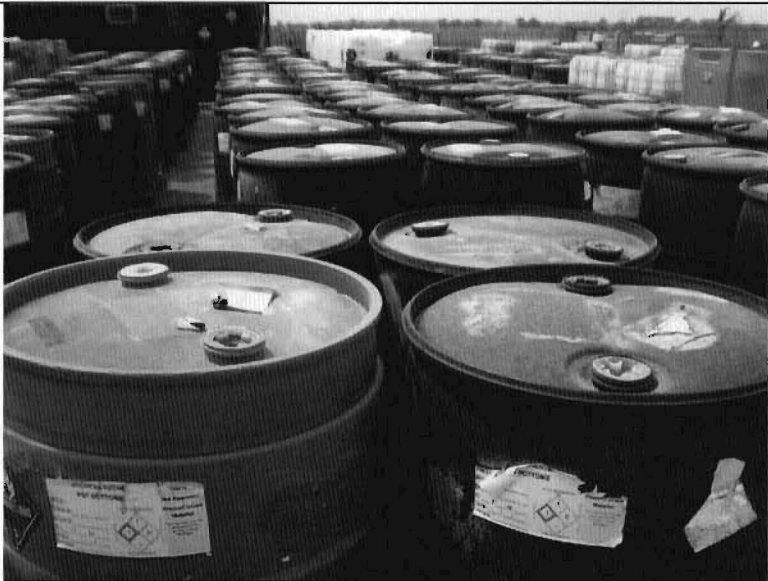
Photographer:		Les Branscum, ADEQ			Witness:		Penny Wilson, ADEQ
Photo #	47	Of	67		Date:	28 AUG 07	Time:
Description:		Row 20 facing west on drum pad. Drums in front are labeled 'm-Bromofluorobenzene Recycle'.

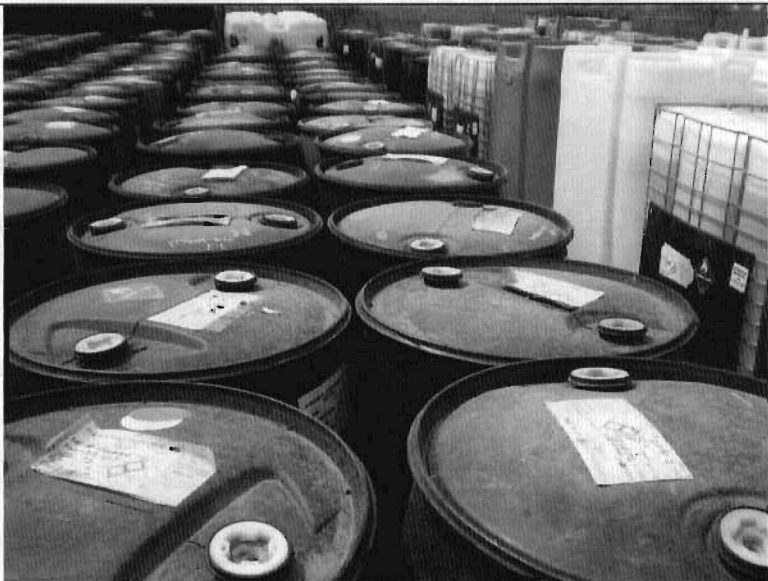
Location:	Diaz Intermediates Corp., 301 Wyanoke Rd., West Memphis, AR 72301						
Photographer:	Les Branscum, ADEQ			Witness:	Penny Wilson, ADEQ		
Photo #	48	Of	67		Date:	28 AUG 07	Time: 1423
Description:	Last rows on drum pad progressing from south to north. Photo is facing NW.

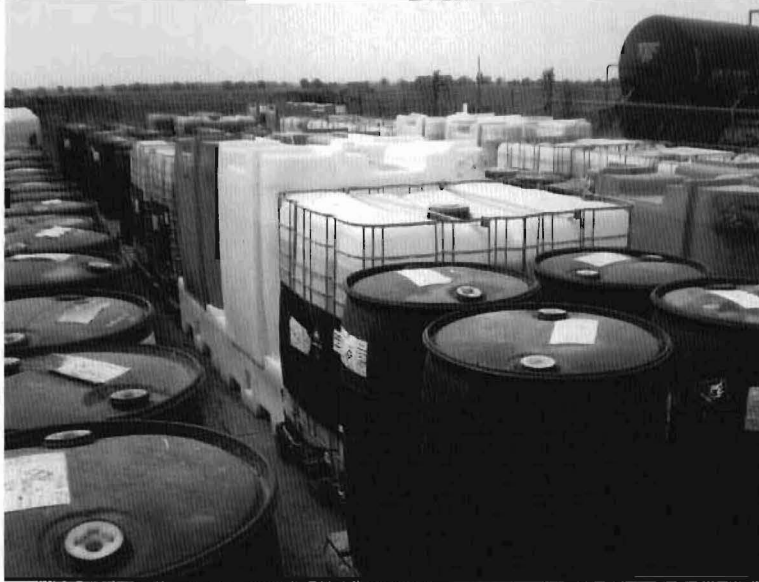
Photographer:	Les Branscum, ADEQ			Witness:	Penny Wilson, ADEQ		
Photo #	49	Of	67		Date:	28 AUG 07	Time: 1425
Description:	Drum in upper left corner of photo 48 that appeared black with a blue lid. Drum is discolored by contents. Label indicates contents are 'Fluorobenzene (Recovered) Acidic' and dated 6-30-07.

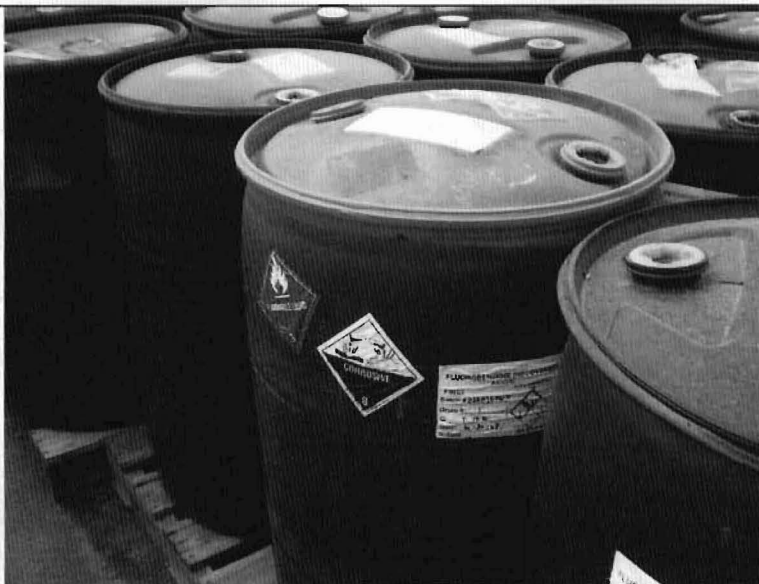
Location:	Diaz Intermediates Corp., 301 Wyanoke Rd., West Memphis, AR 72301							
Photographer:	Les Branscum, ADEQ			Witness:	Penny Wilson, ADEQ			
Photo #	50	Of	67		Date:	28 AUG 07	Time:	1426
Description:	Drums at east end of drum pad, facing north. Drum to right is labeled 'MBFB Nondistilled Water'

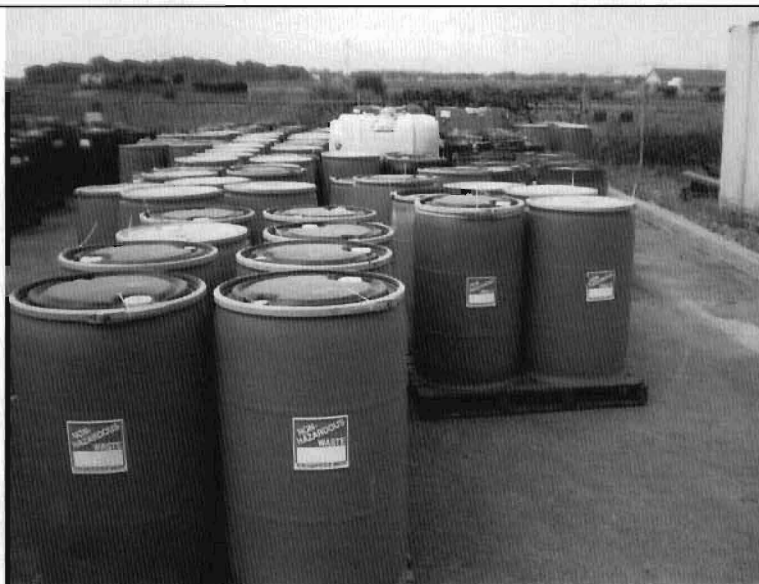
Photographer:	Les Branscum, ADEQ			Witness:	Penny Wilson, ADEQ			
Photo #	51	Of	67		Date:	28 AUG 07	Time:	1431
Description:	Drums on East end of drum pad, (drums in photo 50 are in upper left corner) majority are non-hazardous.

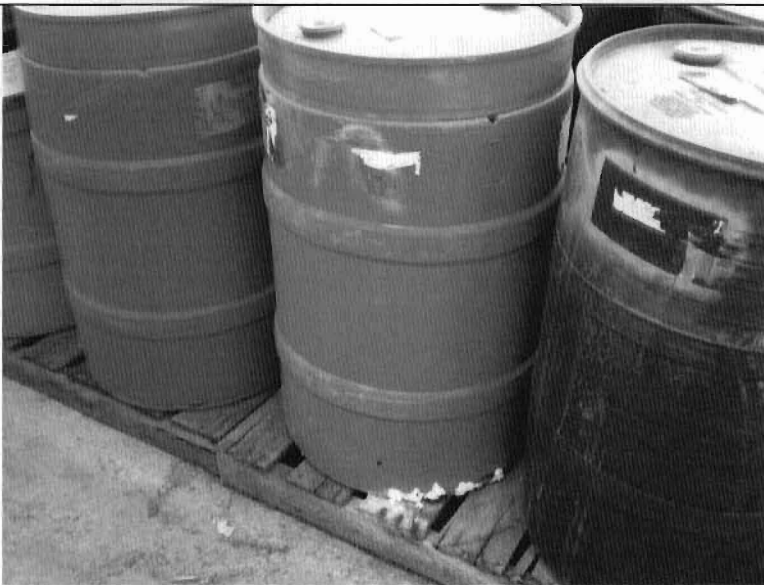
Location:		Diaz Intermediates Corp., 301 Wyanoke Rd., West Memphis, AR 72301					
Photographer:		Les Branscum, ADEQ			Witness:		Penny Wilson, ADEQ
Photo #	52	Of	67		Date:	28 AUG 07	Time: 1434
Description:		Leaking drum on right side of drums in photo 51.

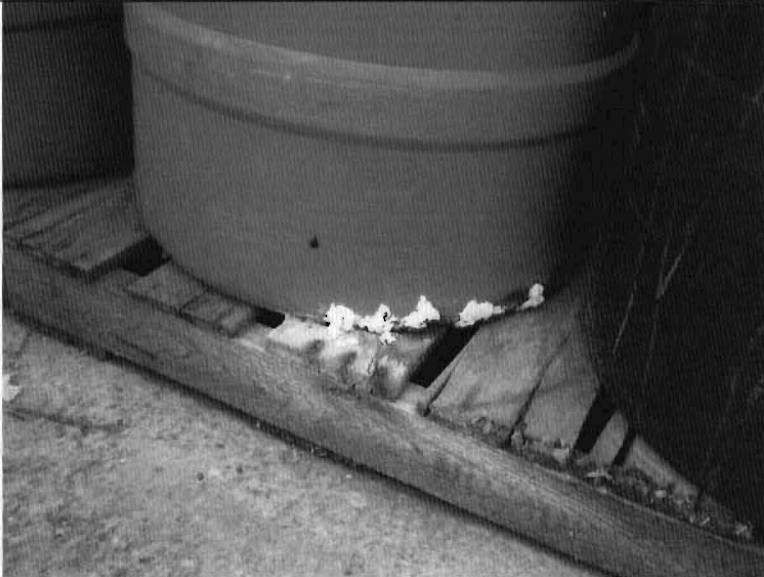
Photographer:		Les Branscum, ADEQ			Witness:		Penny Wilson, ADEQ
Photo #	53	Of	67		Date:	28 AUG 07	Time: 1434
Description:		Close up of leaking drum showing salt like crystals that have formed around the damaged base of the drum. The leaking material had solidified by the time of the photo, no liquid was seen.

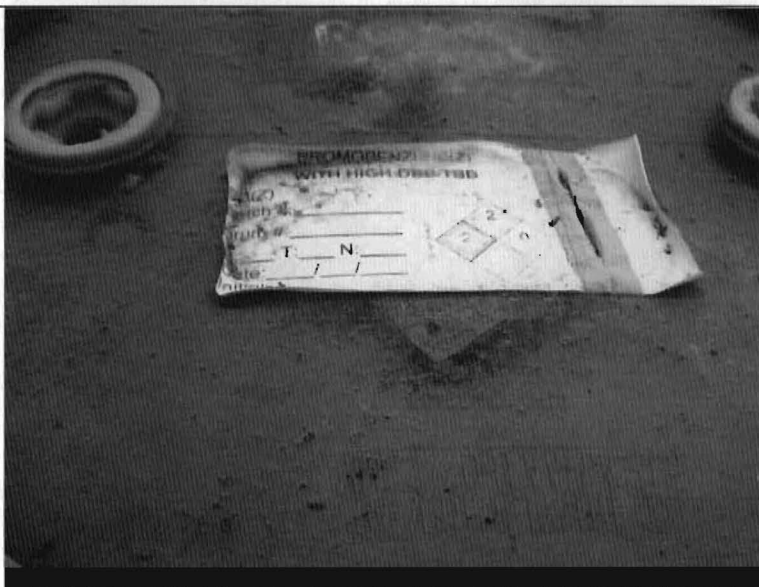
Location:	Diaz Intermediates Corp., 301 Wyanoke Rd., West Memphis, AR 72301							
Photographer:	Les Branscum, ADEQ			Witness:	Penny Wilson, ADEQ			
Photo #	54	Of	67		Date:	28 AUG 07	Time:	1437
Description:	Close up of label on damaged drum. Label indicates contents are 'Bromobenzene (Z) with high DBB/TBB'.

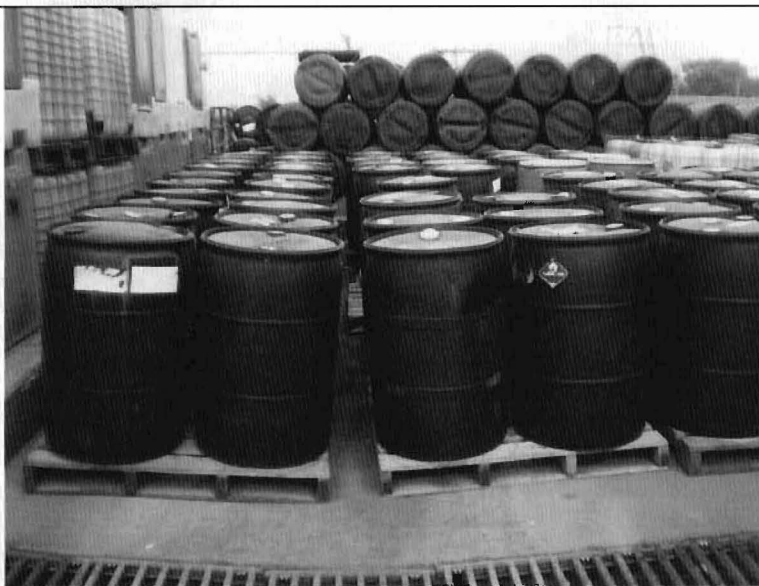
Photographer:	Les Branscum, ADEQ			Witness:	Penny Wilson, ADEQ			
Photo #	55	Of	67		Date:	28 AUG 07	Time:	1439
Description:	North pad, east of previous photos and facing east showing full drums in foreground and empties stacked on their side in background.

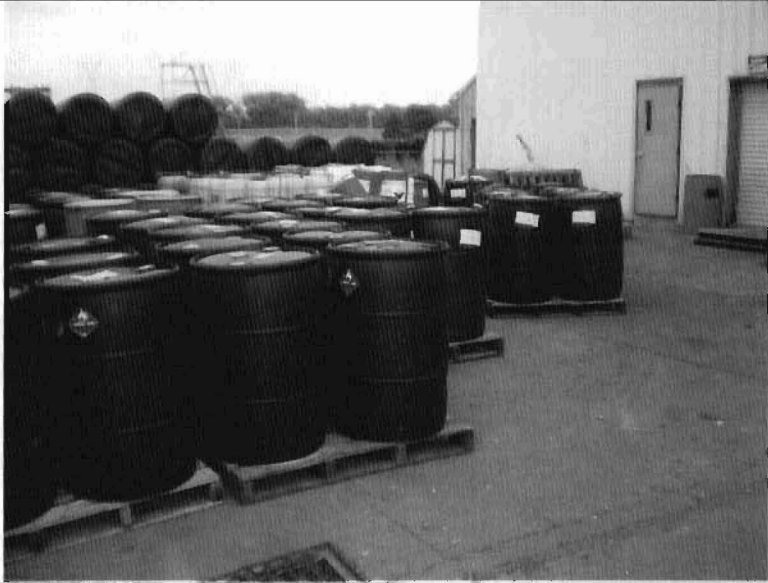
Location:		Diaz Intermediates Corp., 301 Wyanoke Rd., West Memphis, AR 72301							
Photographer:		Les Branscum, ADEQ				Witness:		Penny Wilson, ADEQ	
Photo #	56	Of	67		Date:	28 AUG 07	Time:	1439	
Description:		Continuation of drums in photo 55, facing east. Process Building is to the right in background.

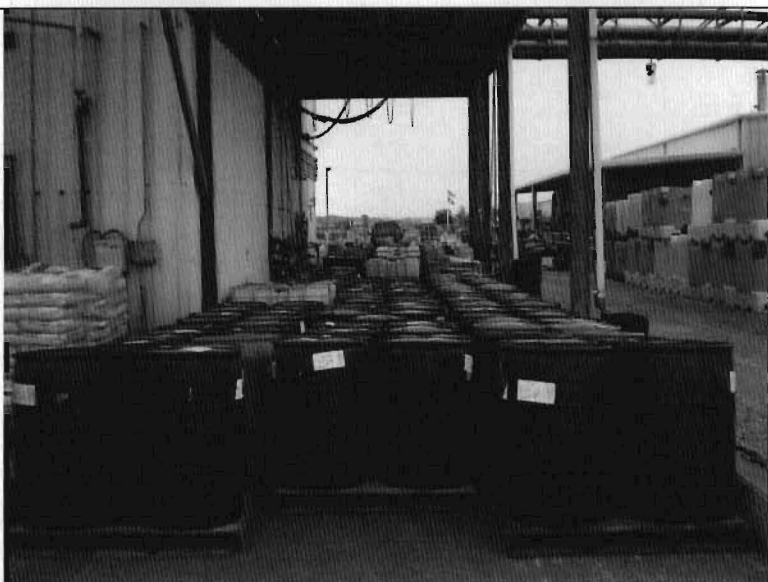
Photographer:		Les Branscum, ADEQ				Witness:		Penny Wilson, ADEQ	
Photo #	57	Of	67		Date:	28 AUG 07	Time:	1443	
Description:		Drums on Bulk Truck Pad, facing south. Process Building is to the left.
